KOMPSAT Imagery Quality Report

- KOMPSAT-2, 3, 3A (June ~ July 2020) -

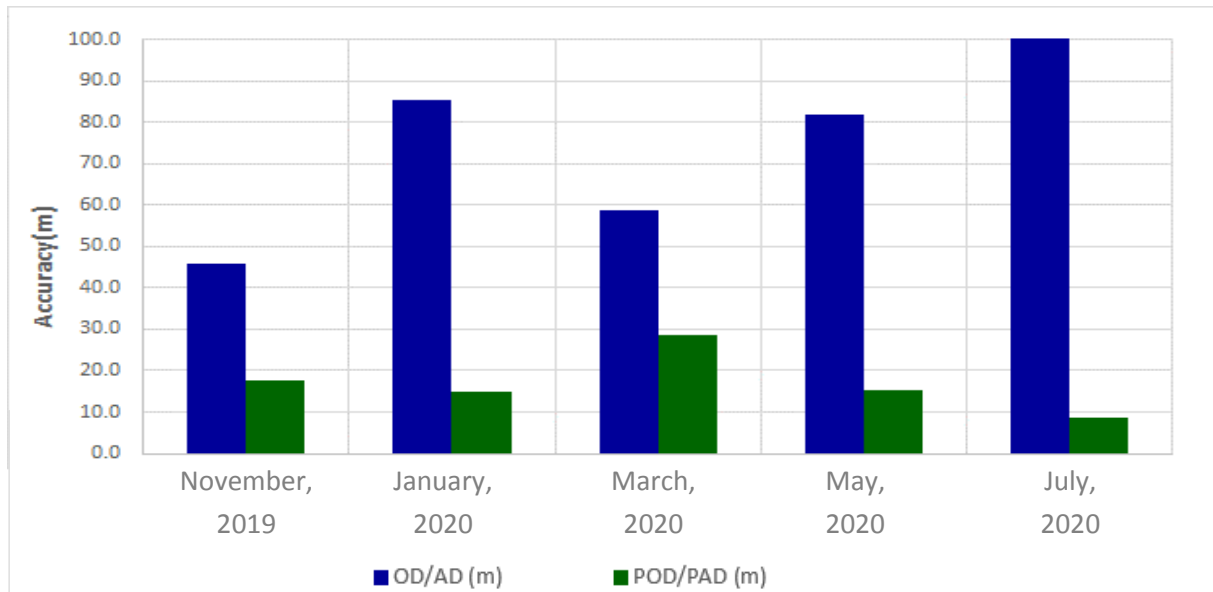
KOMPSAT-3 Location Accuracy

KOMPSAT-3	8.7m RMSE	9.0%

※ Above location (geometric) accuracy is a result processed with POD/PAD.

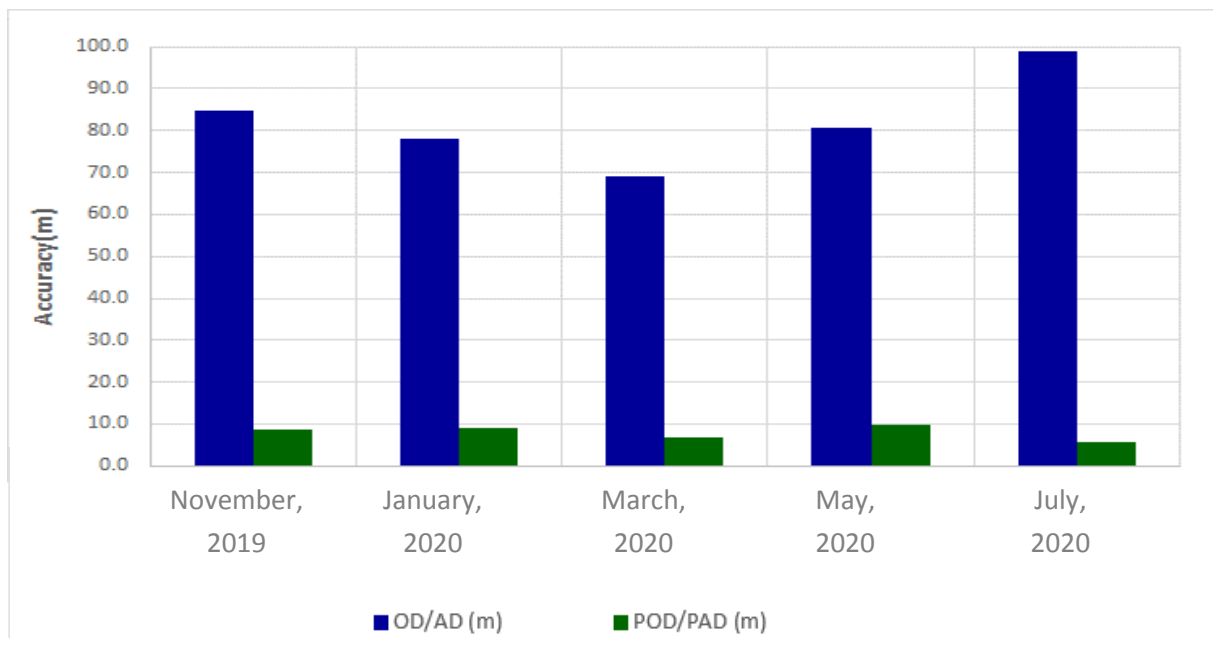
KOMPSAT-3A Location Accuracy

KOMPSAT-3A	5.9m RMSE	12.7%

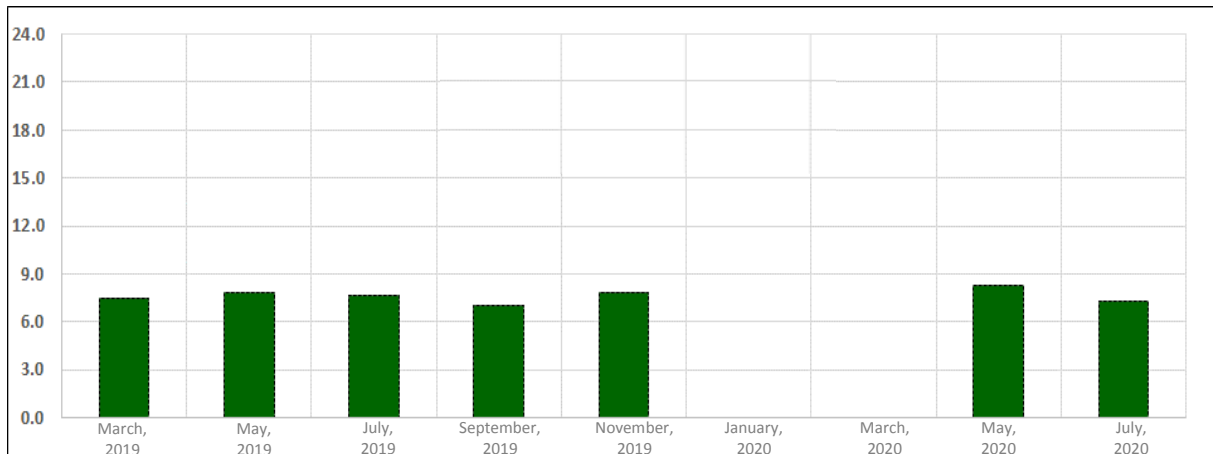
KOMPSAT-2 MTF

※ No valid scenes were acquired from January to March.

KOMPSAT-2	N/A	7.3%

※ Above MTF values are measured with MTFC off.

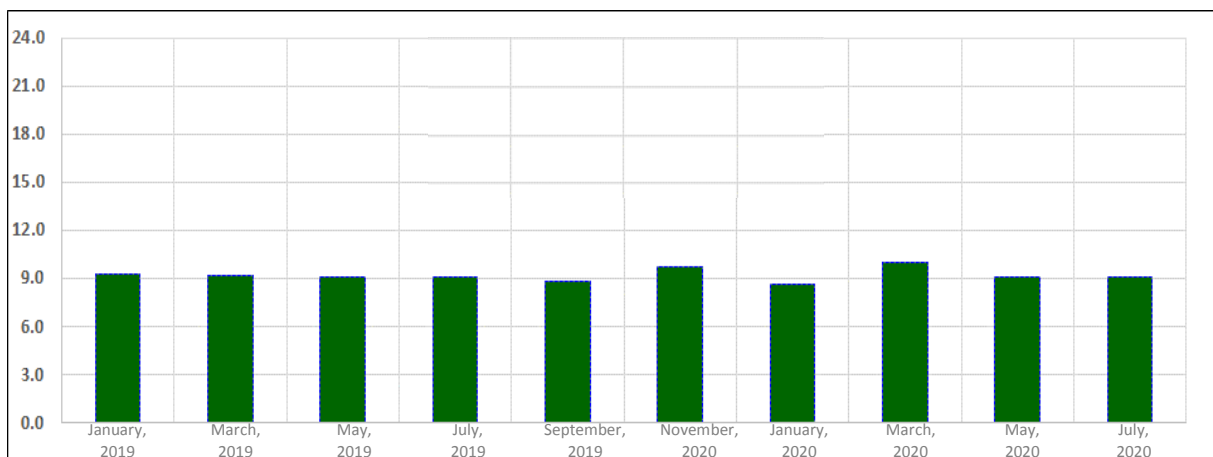
KOMPSAT-3 MTF

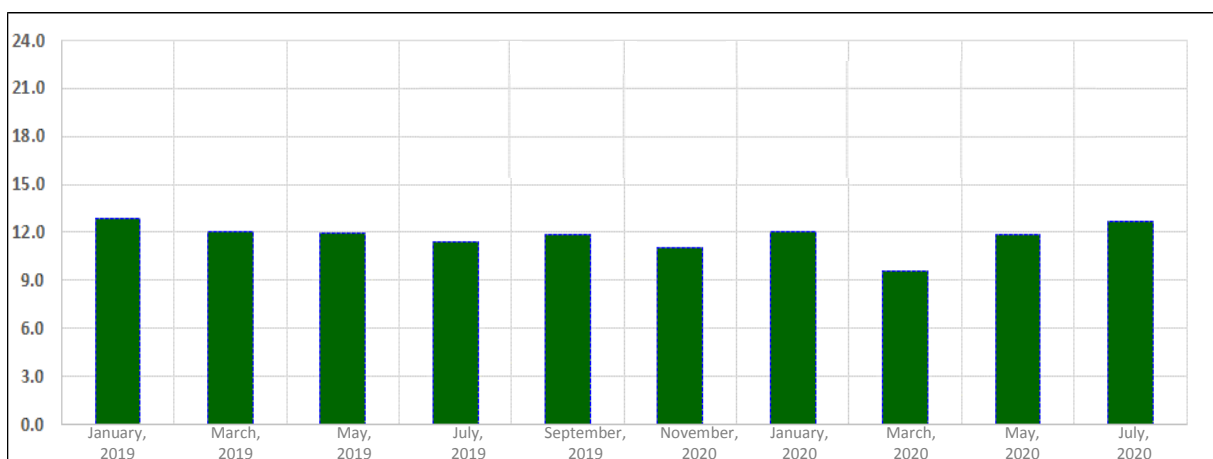
KOMPSAT-3A MTF
